# Manhole Inspection Summary

Manhole # S51M\_\_047MH

Insp Date: **4/3/08 12:02 PM**

**Location** Address: **2700 dillon**

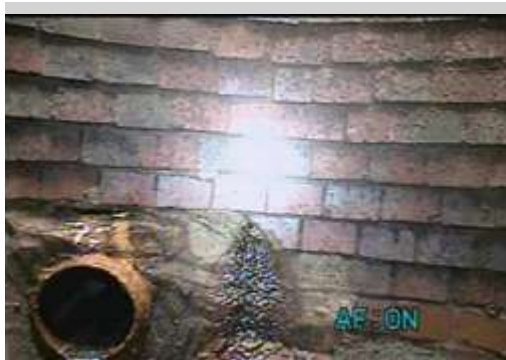
Defect 5

Infiltration: ☐ None ☐ Joint ☐ Cracks ☐ Mortar ☐ Roots ☒ **Wall**

infiltration in barrel

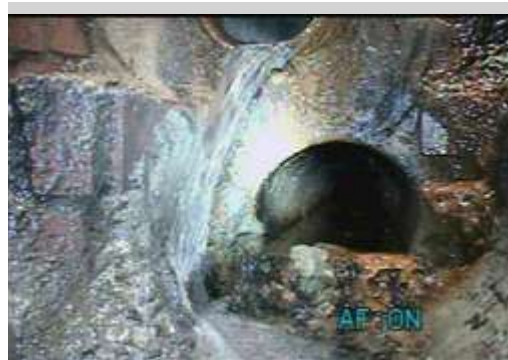
Defect 4

Condition: ☐ Sound ☐ Cracked ☐ Root Intrusion ☐ Deteriorated ☐ Leaks ☒ **Debris**

channel debris

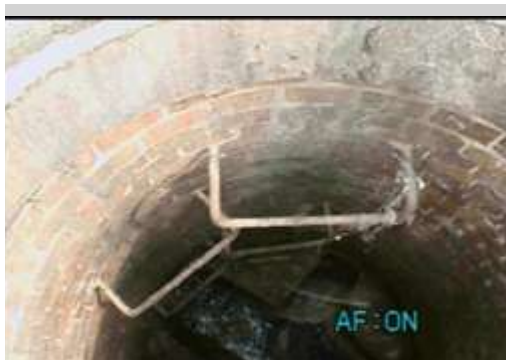
Defect 3

Count: **5** Missing: **0** ☒ **Corroded**

steps

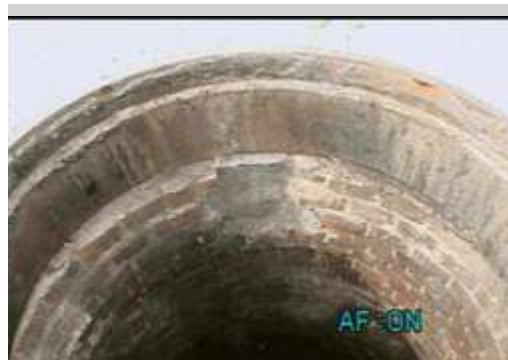
Defect 2

Condition: ☐ Sound ☐ Cracked ☐ Root Intrusion ☐ Loose Brick ☒ **Deteriorated**

frame adjustment

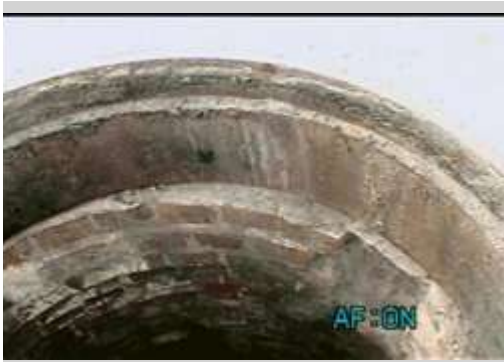
### Defect 1

Offset: **1** (in.)

offset

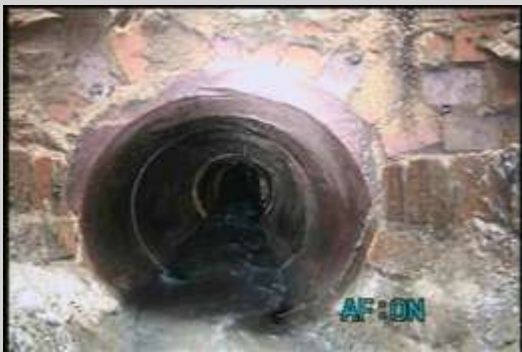
12 O'Clock Outflow

Pipe Height: **0** (in.) Direct  
Pipe Material: **Clay** ☐ Pipe Lined  
Invert Depth: **9.92** (ft.) Flow Characteristics: **Fast**  
Deposits: ☒ None ☐ Mud ☐ Sludge ☐ Debris ☐ Grease  
Silt Depth: **0** (in.) Deposits Extent:  
Infiltration: **None** Pipe Seal Cond: **Unknown**

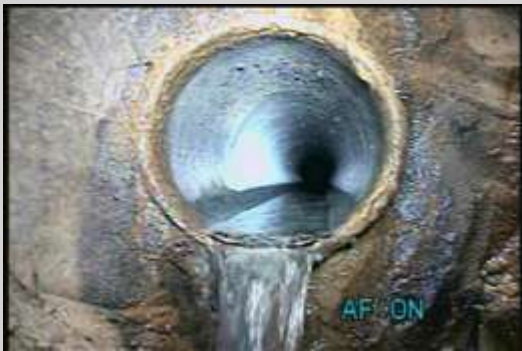
3 O'Clock Inflow

Pipe Height: **0** (in.) Direct  
Pipe Material: **Clay** ☐ Pipe Lined  
Invert Depth: **8.66** (ft.) Flow Characteristics: **Slow**  
Deposits: ☒ None ☐ Mud ☐ Sludge ☐ Debris ☐ Grease  
Silt Depth: **0** (in.) Deposits Extent:  
Infiltration: **None** Pipe Seal Cond: **Unknown**

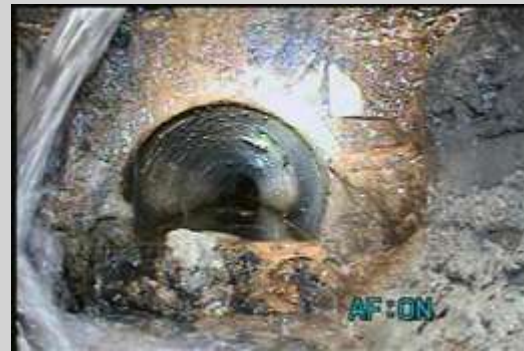
Drop In @ 3 O'Clock

Drop: **Outside Direct**  
Angled: Reading: **0.00** (ft.)  
Inv Depth: **9.58** (ft.)  
Drop Condition: **Open**

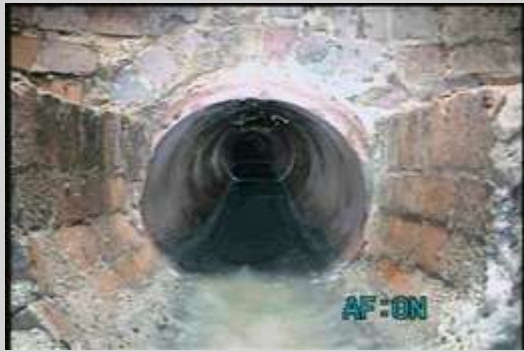
6 O'Clock Inflow

Invert Depth: **9.83** (ft.) Flow Characteristics: **Fast**

Infiltration: **None** Pipe Seal Cond: **Unknown**

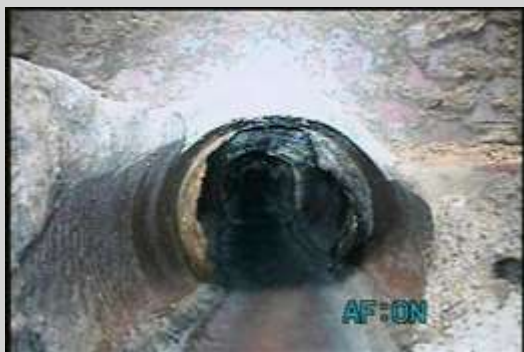
9 O'Clock Inflow

Invert Depth: **9.46** (ft.) Flow Characteristics: **Fast**

Infiltration: **None** Pipe Seal Cond: **Unknown**
